# Manhole Inspection Summary

Manhole # S55A2\_008MH

Insp Date: **5/20/08 11:01 AM**

**Location** Address: **3501 Asiatic Ave.**

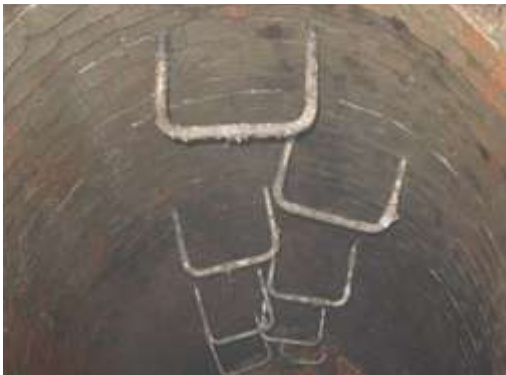
Steps

**Steps** Count: **8** Missing: **0** ☐ Corroded

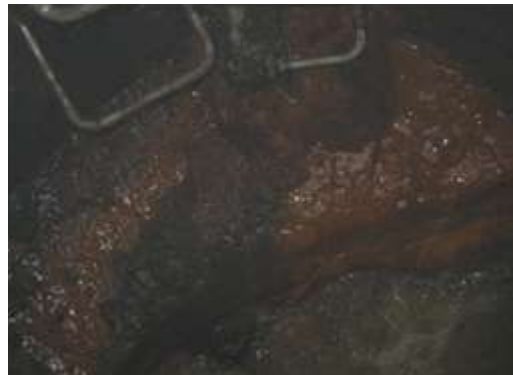
Defect 2

**Bench** ☒ Exists Material: **Brick** ☐ Parged

Condition: ☐ Sound ☐ Cracked ☐ Root Intrusion ☒ Deteriorated ☐ Leaks ☐ Debris

Bench deterioration

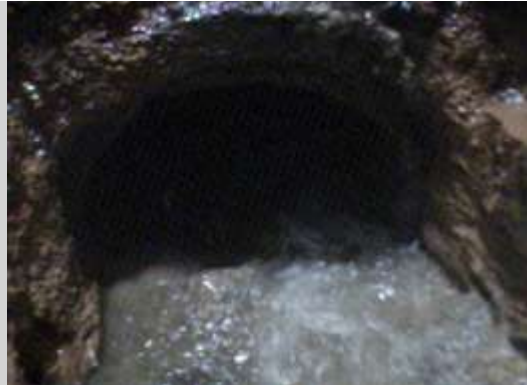
12 O'Clock Outflow

24 in. Circular Gravity Sewer  
Pipe Out @ 12 O'Clock

Pipe Height: **24** (in.) Rod and Bar (Angled)  
Pipe Material: **Unknown** ☐ Pipe Lined  
Invert Depth: **17.08** (ft.) Flow Characteristics: **Fast**  
Deposits: ☒ None ☐ Mud ☐ Sludge ☐ Debris ☐ Grease  
Silt Depth: (in.) Deposits Extent:  
Infiltration: **None** Pipe Seal Cond: **Sound**

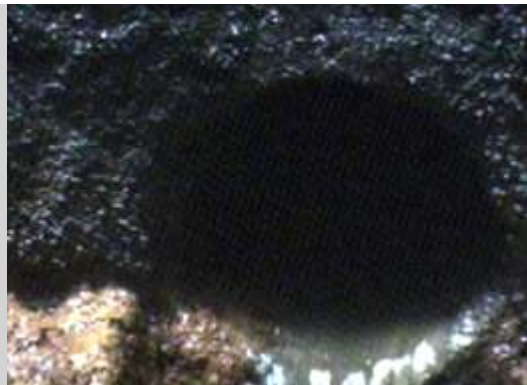
7 O'Clock Inflow

24 in. Circular Gravity Sewer  
Pipe In @ 7 O'Clock

Pipe Height: **24** (in.) Rod and Bar (Angled)  
Pipe Material: **Unknown** ☐ Pipe Lined  
Invert Depth: **15.50** (ft.) Flow Characteristics: **Fast**  
Deposits: ☒ None ☐ Mud ☐ Sludge ☐ Debris ☐ Grease  
Silt Depth: (in.) Deposits Extent:  
Infiltration: **None** Pipe Seal Cond: **Sound**
